As part of the three-fold President General's Project, "Preserve the Past, Enhance the Present, Invest in the Future," efforts to restore the DAR Headquarters buildings have focused on a number of critical enhancements, specifically roof repairs. In the first 18 months of the Wright Administration, two major roofing projects were completed successfully. Plans were under way to begin the next phase of exterior roof work when a series of unique events revealed a serious problem with the most recognizable "roof" of the entire Headquarters complex.

Ways to Support the DAR Library Lay Light Restoration

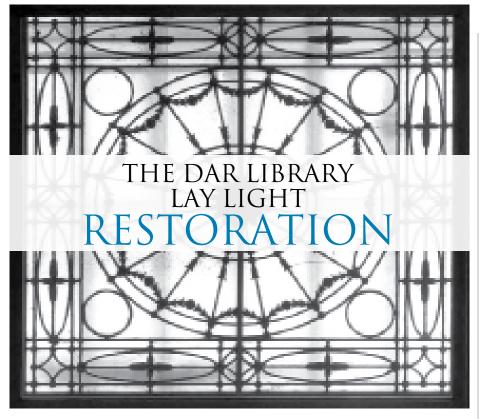
Poor ventilation allowed moisture to build up between the lay light and skylight, contributing to the corrosion and softening of the zinc cames. The cupola that sits atop the skylight is inadequately equipped to withstand heavy, blowing rain that can then lead to water leakage above the lay light. Years of leakage have resulted in dirt buildupevidenced by the brown staining on the center panel-which

is the problem most visible when the lay light is viewed from below.
